TECHNICAL REPORT CERC-88-4

EFFECTIVENESS OF EXPEDIENT LEVEE-RAISING STRUCTURES

Experimental Model Investigation

Coastal Engineering Research Center

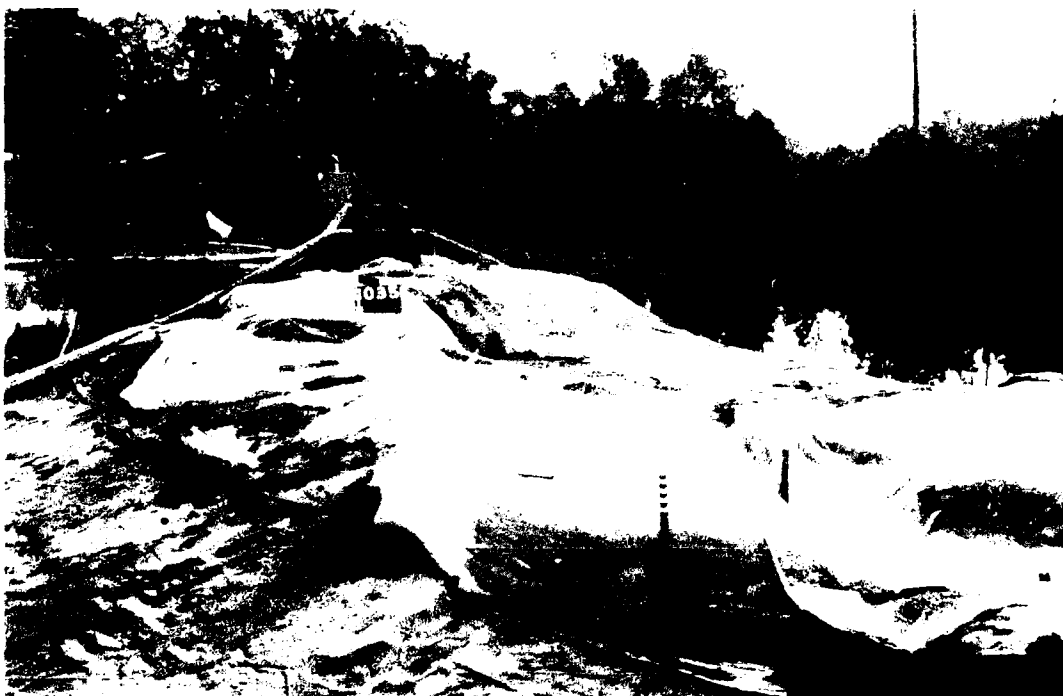
below the breach elevation. Photos 30 and 31 show the condition of the test section after the small basin was drained. The structure was uncovered (Photo 32), and a cross-sectional sounding was made through the breach in the structure (Plate 6).

Photo 30. Riverside view of Section 2-2 after 34.5 hr of wave action at the 1.0-ft water level

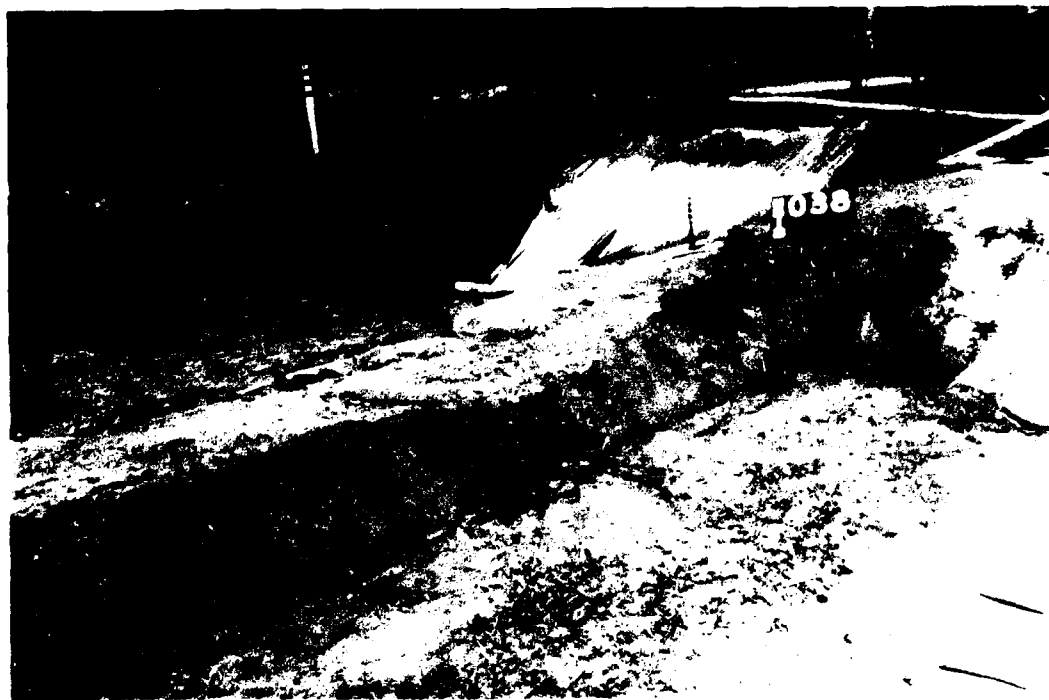
Photo 32. Landside view of Section 2-2 after 34.5 hr of wave action
at the 1.0-ft water level (poly covering removed)

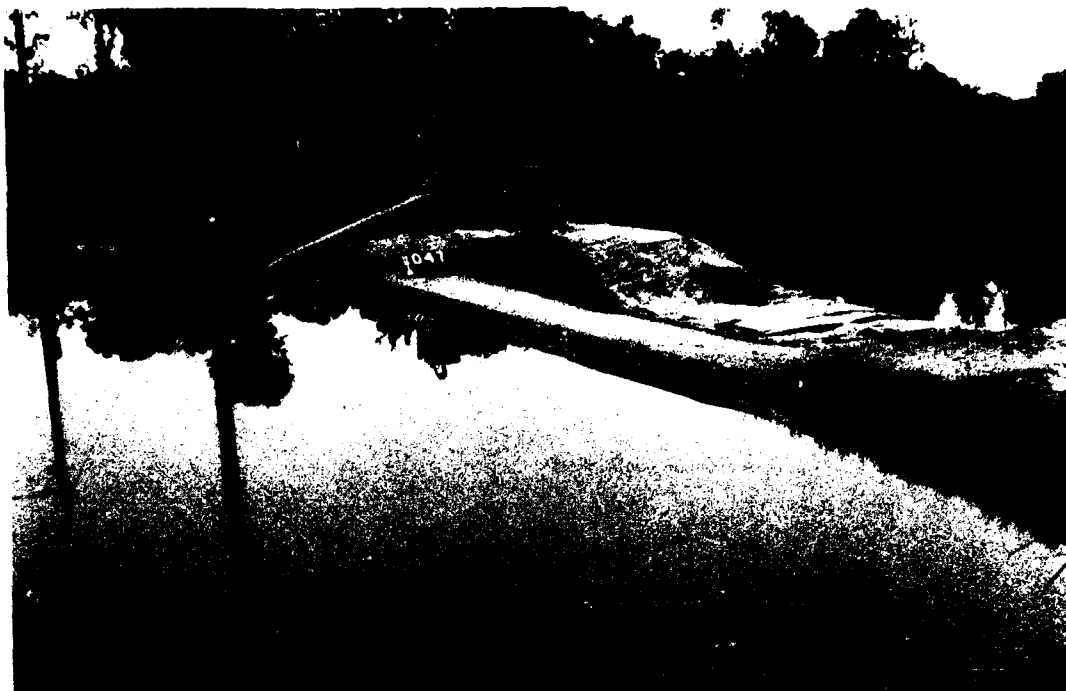
19. Section 2-3 was exposed to 24, 46, and 47 hr of 0.5-, 1.0-, and 1.5-ft static differential heads, respectively. Photos 35 and 36 show the condition of Section 2-3 at the end of the static head tests. The structure showed no seepage during the 0.5-ft static head test, but the landside toe did become spongy to the touch. Some very minor seepage occurred during the 1.0-ft static head test and increased for the 1.5-ft static head test. This seepage was an insignificant amount and did not cause obvious erosion or

Photo 35. Riverside view of Section 2-3 after testing 0.5-, 1.0-, and 1.5-ft static differential heads

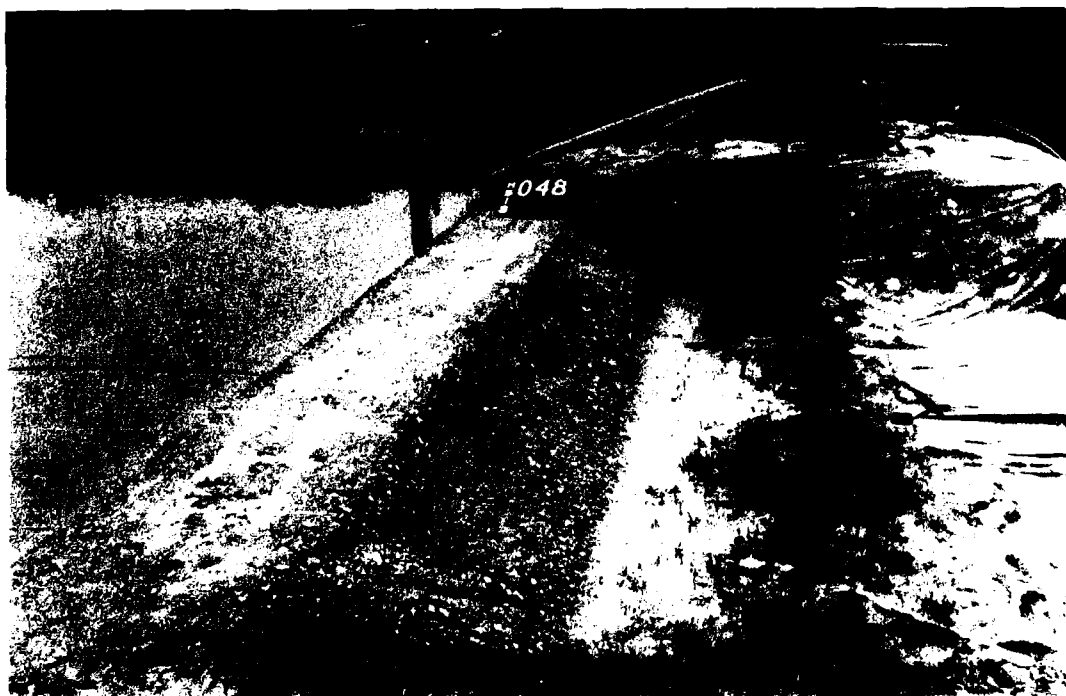
stability problems. The structure was exposed to approximately 5 in. of rain during the static head tests which caused some minor surface erosion and accounts for a significant portion of the mud and water buildup on the land-side of Section 2-3 (Photo 36).

Photo 36. Landside view of Section 2-3 after testing 0.5-, 1.0-, and 1.5-ft static differential heads

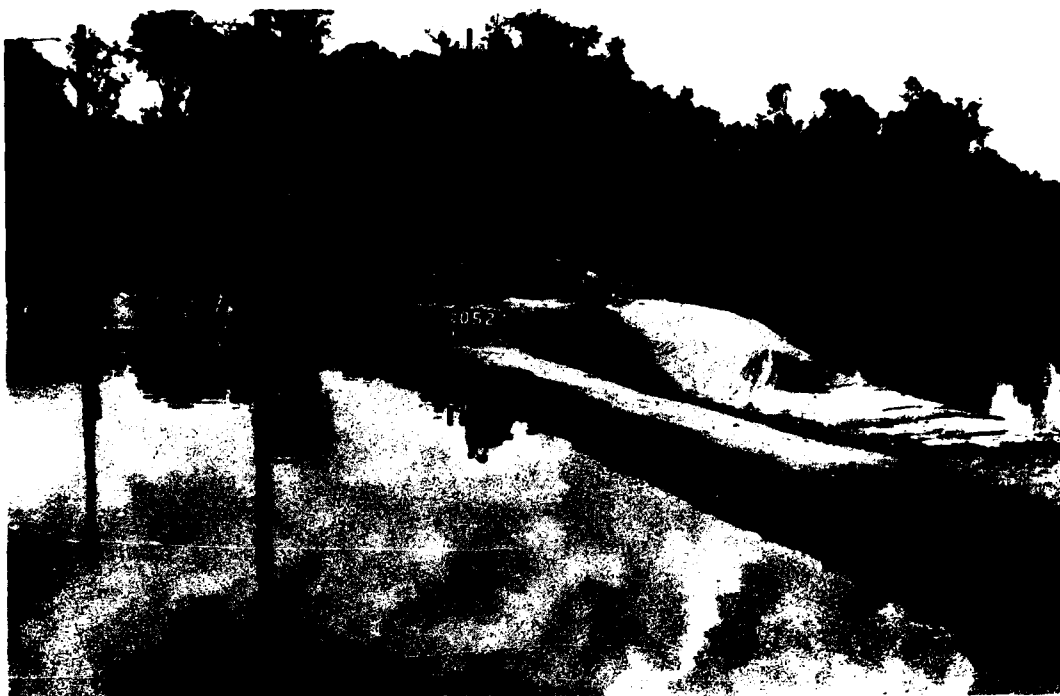
Photo 37. Riverside view of Section 2-3 after 2.5 hr of wave action at the 1.0-ft water level

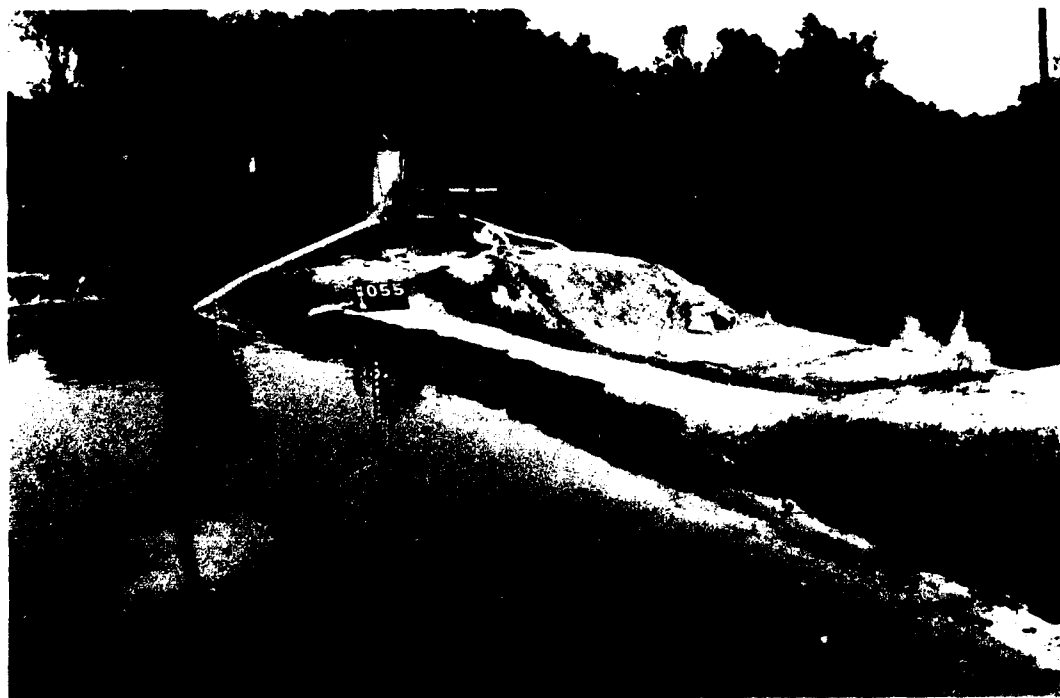
20. Following the static head tests, the water level was lowered to 1.0 ft, and the structure was exposed to 28 hr of wave action over a period of 309.5 hr. Through a process of undermining and block failures, the first 5 to 6 hr of wave action produced rapid erosion of the clay gravel. During the erosion process, a graded beach was forming riverward of the section. Fine particles (clays, silts, and sands) were moved away by wave action, but the gravel was graded and deposited in front of the eroding embankment. The sloping gravel beach caused waves to break and dissipate a large portion of their energy; thus the erosion slowed considerably after 6 hr of wave action. As the gravel beach widened, erosive effects of the waves continued to diminish, and erosion was progressing at a very slow rate when the small basin was drained to document structure condition after 19 hr of wave action. Prior to draining the small basin, it was noted that the seepage rate had increased as the structure eroded away, but seepage had not yet caused any obvious stability problems. Photos 37-40 show the section condition after 2.5, 10.5, and 19 hr of wave action. The gravel beach is very noticeable in Photo 39.

Photo 38. Riverside view of Section 2-3 after 10.5 hr of wave action at the 1.0-ft water level

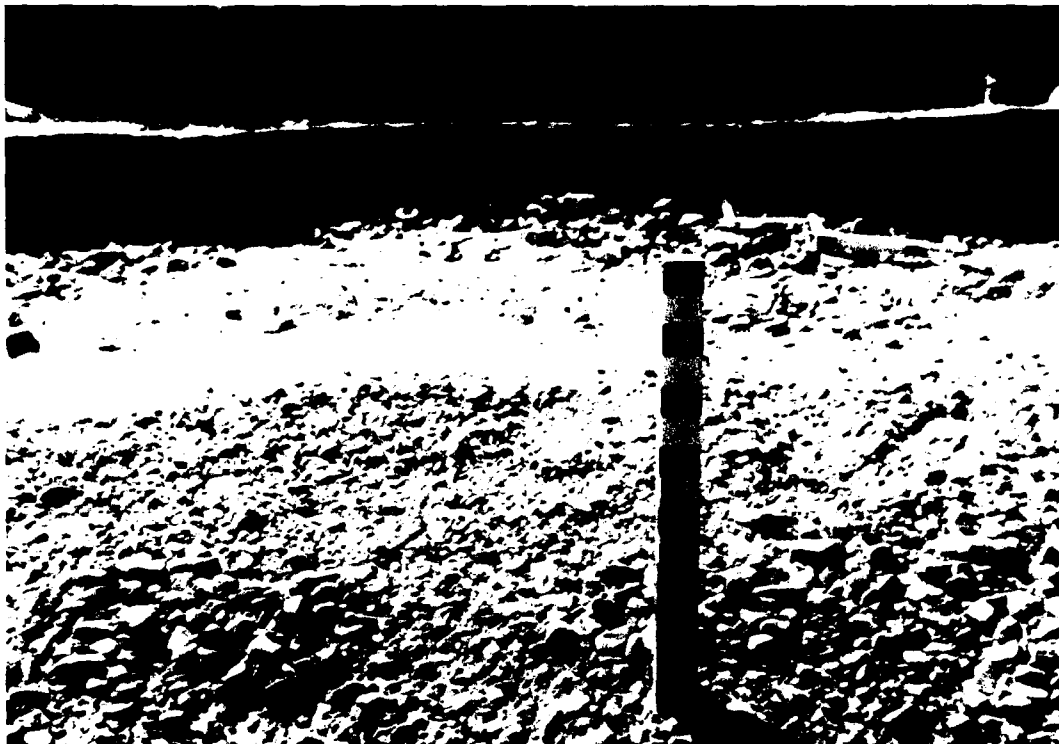
adjusted to the higher water level and once again had stopped erosion. The small basin was drained, and the structural condition was documented with Photo 42 and cross-sectional soundings (Plate 10). Photo 43 shows a close-up of the gravel and sand beach that formed on the riverside of the eroded section.

Photo 43. Close-up of gravel and sand beach formed on riverside of Section 2-3

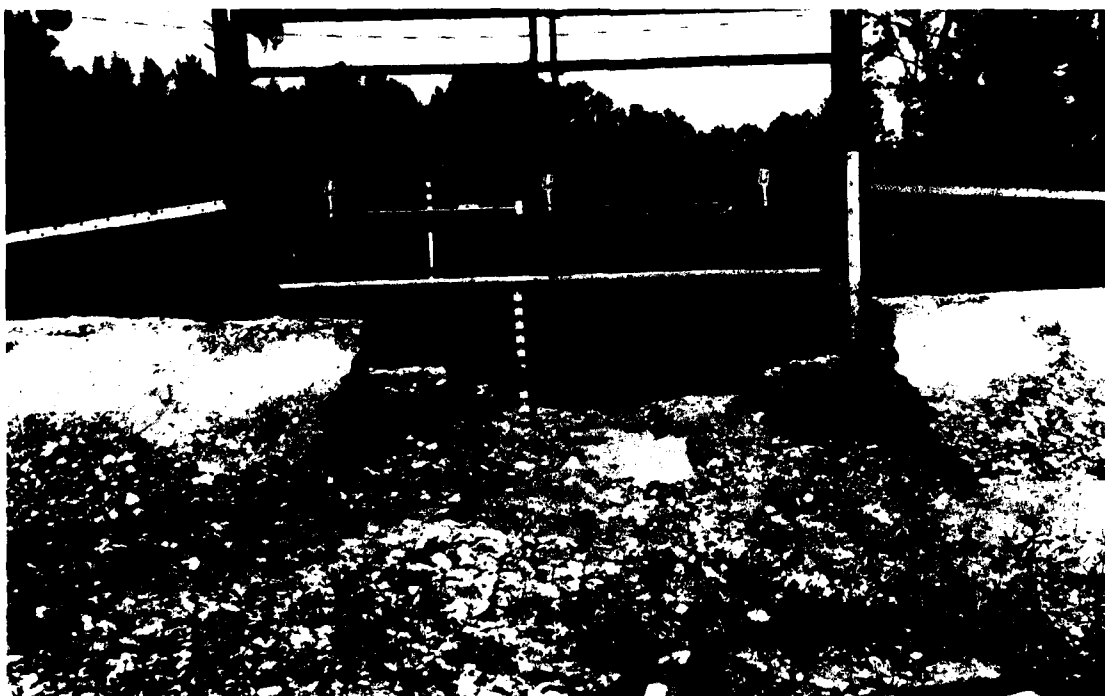
Photo 46. Close-up of breach through Section 2-3 (end of test)

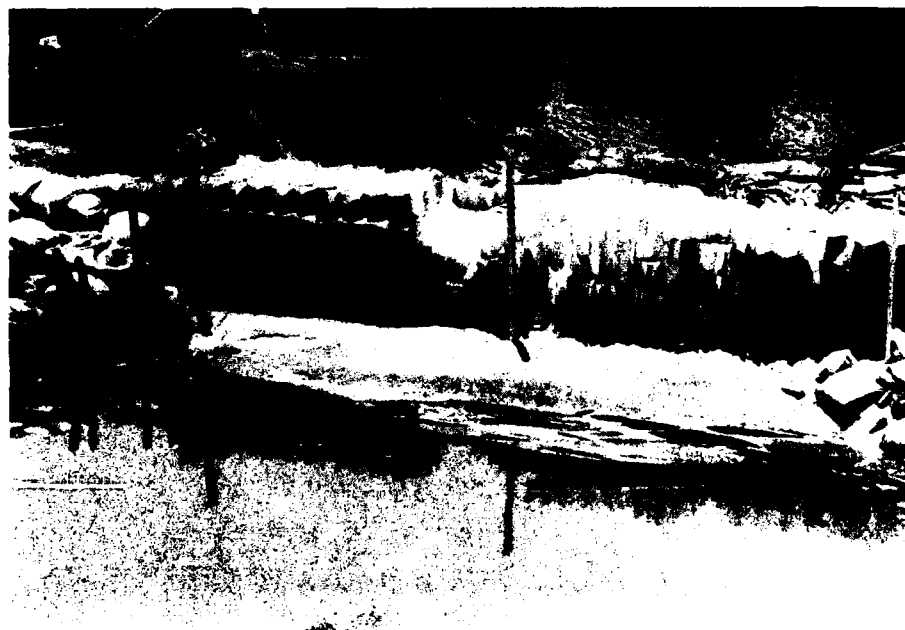
Photo 120. Riverside view of Section 4-2 at end of entire test

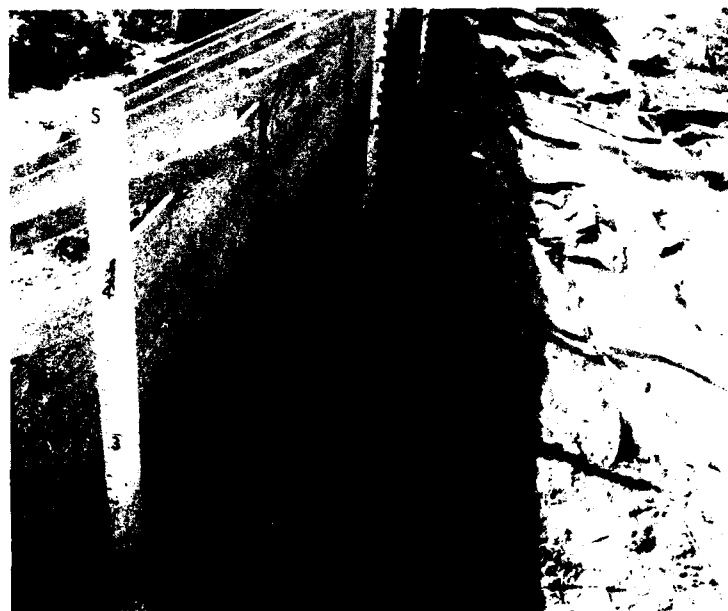
Photo 162. Riverside close-up showing
failure point of Section 4-3-C

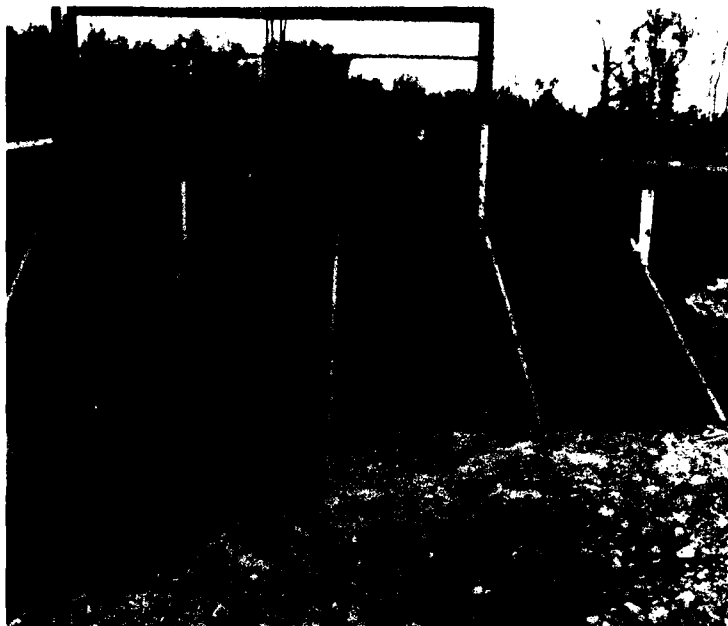
Photo 163. Landside view showing eroded earth backing of Section 4-3-C

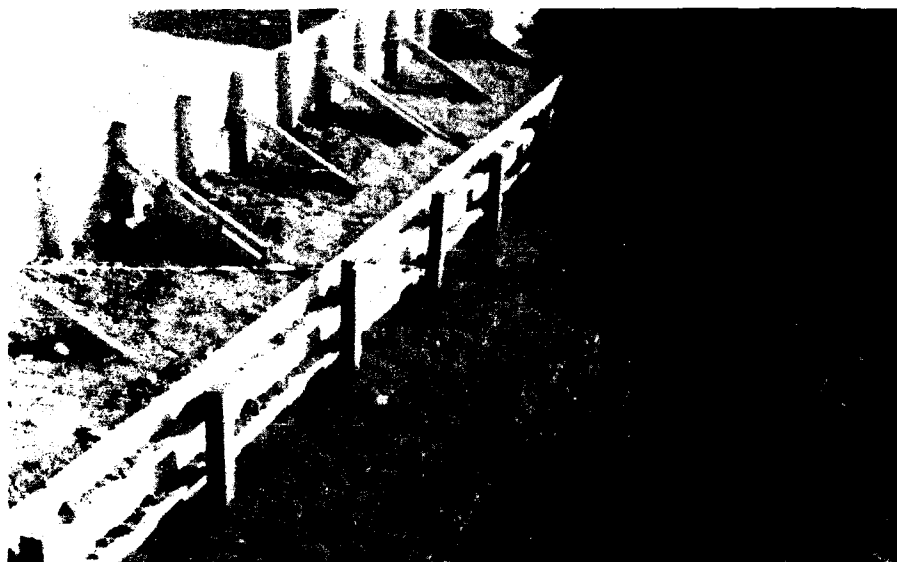
Photo 203. Landside view of Section 4-5 after it failed to retain 1.0-ft static differential head

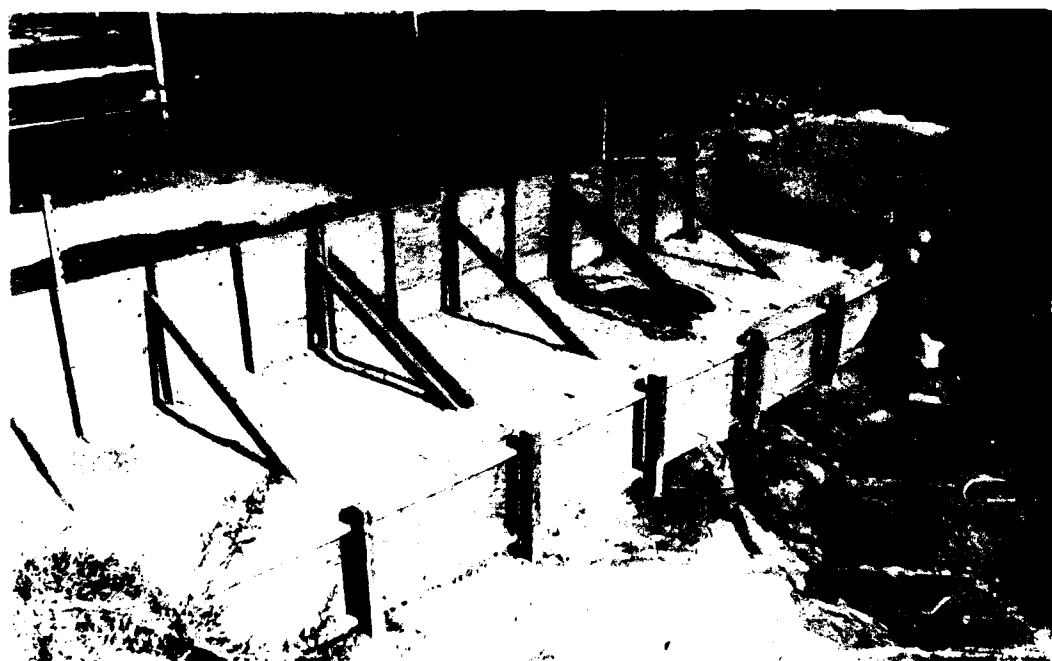
Photo 276. Landside view of Section 6-3 after failure at the 2.0-ft static differential head

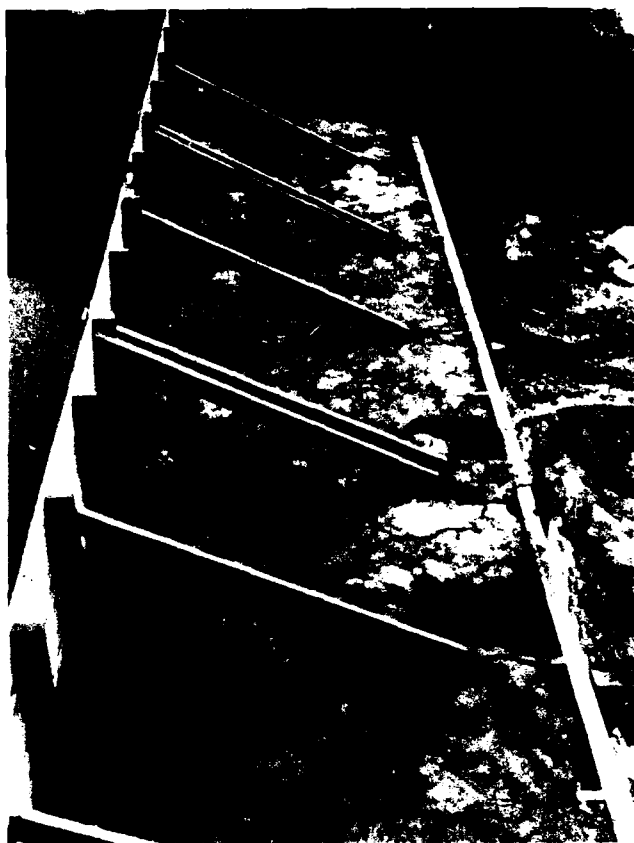
| Test Sections | Reference Plate No. | Structure Performance | | Comments |
|---|---|---|---|---|
| Section 6-4; 6-ft-high, 6-in. entrenched plywood mud box with earth fill | 33 | Stable | -- | Stable with minor seepage for static heads not exceeding 2.0 ft; earth fill failed after 4.0 hrs of 3.0-ft static head. |

Photo 287. End view of Section 6-4 after failure during the 3.0-ft static differential head test (end of test)
